Volume 8 No 4 2022

## RESILIENCE THROUGH DISASTERS – THE REINSTATEMENT AND SUBSEQUENT RESTART OF THE SYDNEY DESALINATION PLANT

# Resilience through disasters – The reinstatement and subsequent restart of the Sydney Desalination Plant

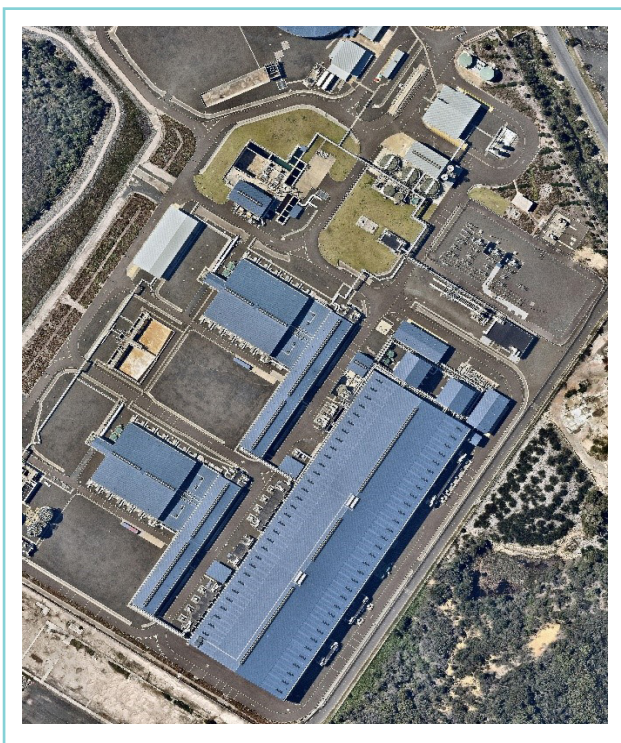
*Photo 1: SDP immediately prior to the storm*

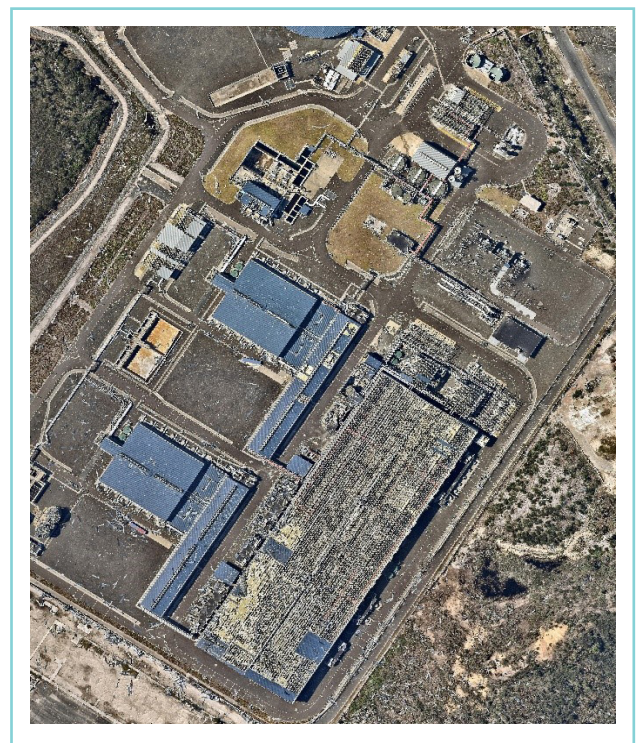
*Photo 2: SDP immediately after the storm*

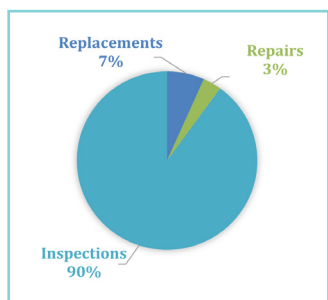
Figure 1: Scope Breakdown of 34,000 assets

The Reinstatement Project proved to be a high risk and complex scope of works, particularly due to the catastrophic and widespread nature of damage and uncertainty of asset damage. All Plant buildings required significant repairs, and of the ~34,000 operational assets inspected, about 15% were completely replaced, with the remaining assets undergoing inspections and repairs to return them to their prior condition. Refer to figures 1 and 2 for a breakdown of the reinstatement scope.

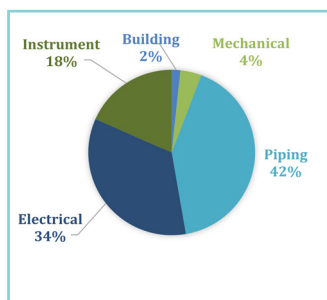
Figure 2: Discipline Breakdown of 34,000 assets

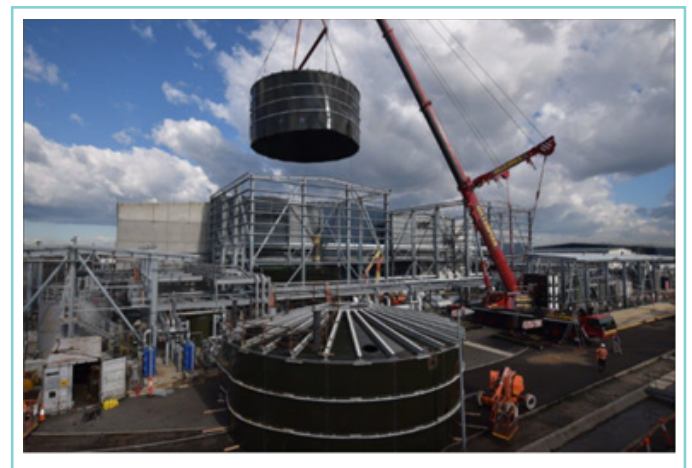
The RO building was subject to the full intensity of the Storm, suffering significant damage. This included the IPTs, which were destroyed by both the direct impacts of debris (such as roof sheeting), as well as the pressures resulting from the Storm conditions, which caused a vacuum inside the tanks.

*Photo 3: Destroyed IPT removal*

Given the size and damage sustained to the existing tank walls, the option of dismantling the tank panels was discounted, with the safest and most efficient option being to cut the tank into pieces, for removal via a 350 t Superlift crane (see Photo 3).

Following the tank removal, the foundations were partially demolished (due to the embedded floor) and two new tanks of the same original specification were installed. The method of installation of the new tanks was typical of panel tank construction, with a deployed jacking system to construct the tank ring by ring until completed.

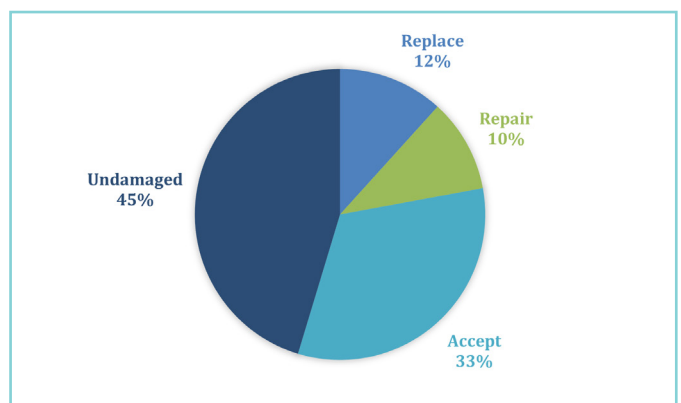
The inspections, which took place over a 2-week period, provided a detailed record of all features on the RO vessels that met the agreed criteria, determined the extent of damage sustained and classified all vessels under the DRUIM system.

*Figure 3: Outcomes of the RO vessel assessment*

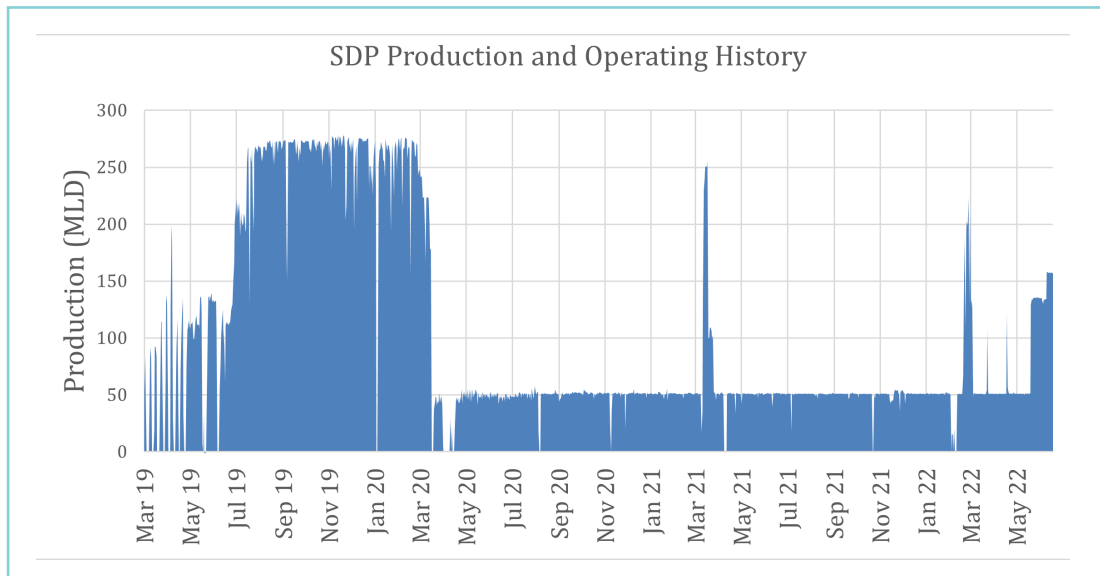
The recent operating history of SDP from its restart in 2019 is depicted in Figure 4 below, split into three key periods:

Figure 4: SDP daily production since restart in 2019, showing the restart, full production (drought response) and emergency response phases of its operation.
